ANNUAL REPORT FOR 2007

**Unnamed Tributaries to Doby Creek Mitigation Site
Mecklenburg County
TIP No. I-3803A**

Prepared By:
Natural Environment Unit & Roadside Environmental Unit
North Carolina Department of Transportation
September 2007

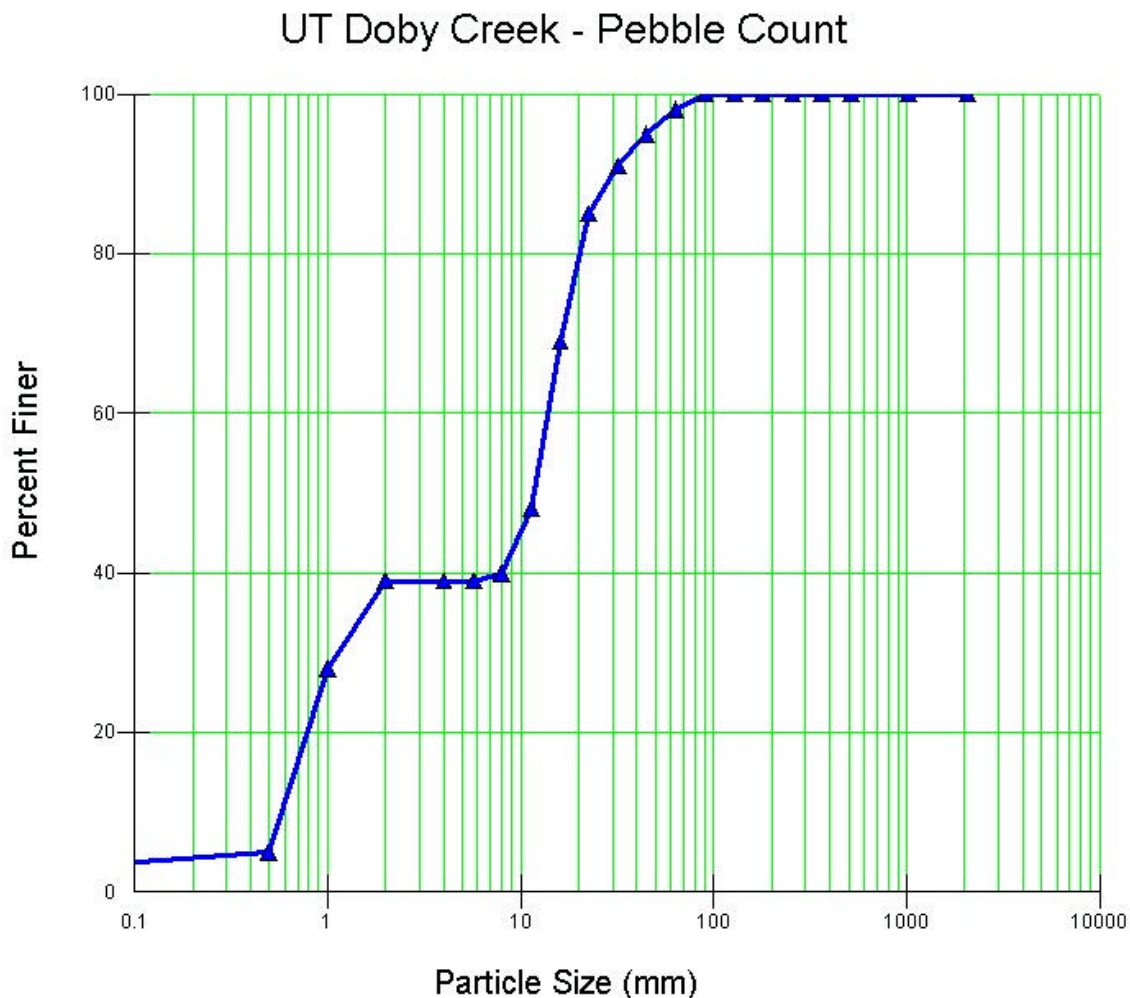
A representative pebble count was taken throughout the surveyed reach. This information is used to determine the stream type. Pre-construction data was not available for UT to Doby Creek. The pebble counts taken during the Year 2006 and Year 2007 monitoring period noted that the D_{50} (50 percent of the sampled population is equal to or finer than the representative particle diameter) for the entire reach of UT to Doby Creek was approximately 6.27 mm and 11.75 mm respectively, which is indicative of a gravel-bed stream.

A chart depicting the particle size distributions for UT to Doby Creek for the Year 2007 is presented below.

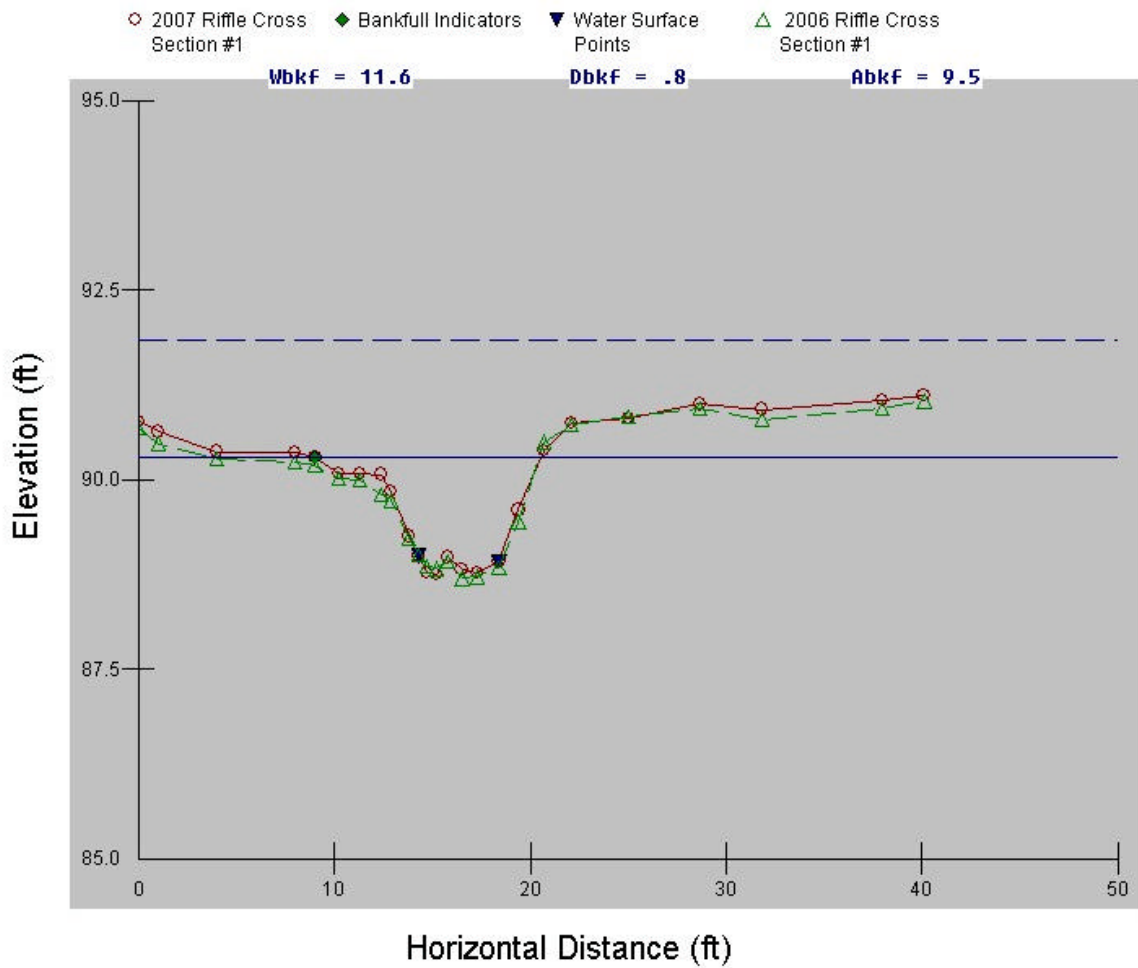
Riffle Cross Section #1

Based on comparisons of 2006 to 2007 monitoring data, both cross sections appear stable with little or no active bank erosion. Graphs of the cross sections are presented in Appendix A. Future survey data will vary depending on actual location of rod placement and alignment, however, this information should remain similar in appearance.

Cross-Section #1 (Riffle) Abbreviated Morphological Summary					
	2006	2007	2008	2009	2010
Bankfull Cross Sectional Area (ft ²)	9.05	9.46			
Maximum Bankfull Depth (ft)	1.49	1.54			
Width of the Floodprone Area (ft)	40.1	40.1			
Bankfull Mean Depth (ft)	0.8	0.82			
Width/Depth Ratio	14.15	14.09			
Entrenchment Ratio	3.54	3.47			
Bankfull Width (ft)	11.32	11.55

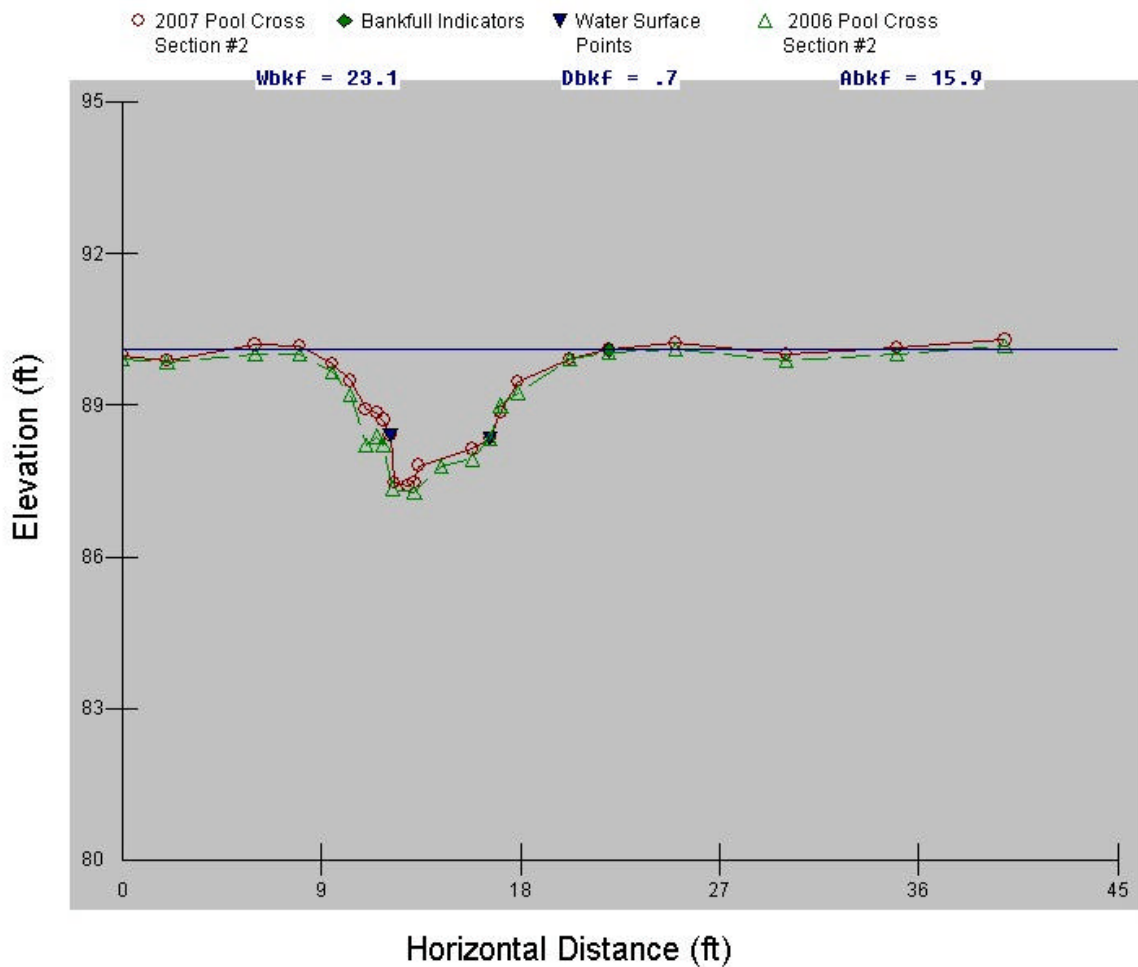
Pool Cross Section #2

Cross-Section #2 (Pool) Abbreviated Morphological Summary*					
	2006	2007	2008	2009	2010
Bankfull Cross Sectional Area (ft ²)	16.85	15.09			
Maximum Bankfull Depth (ft)	2.75	2.7			
Bankfull Mean Depth (ft)	1.06	1.11			
Bankfull Width (ft)	15.85	13.63
